# Manhole Inspection Summary

Manhole # S17K\_\_058MH

Insp Date: **4/8/08 8:48 AM**

**Location** Address: **2537 emerson-pratt alley**

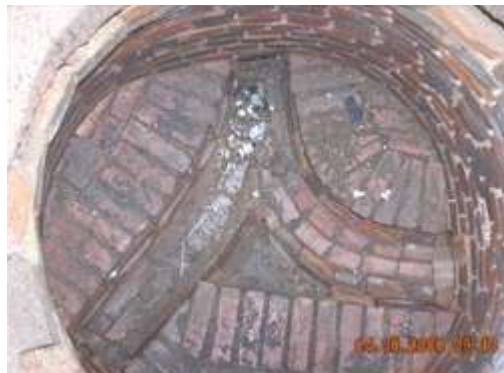
Top View

Condition: ☐ Sound ☐ Cracked ☐ Root Intrusion ☒ **Loose Brick** ☒ **Deteriorated**

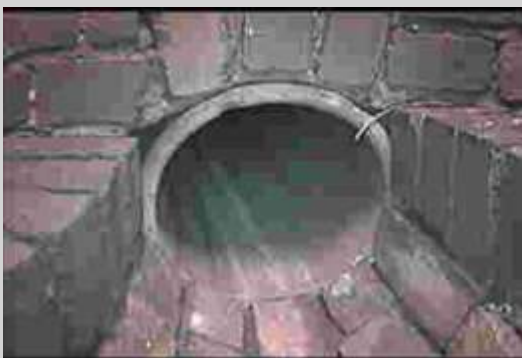
3 O'Clock Inflow

Pipe Height: **8.4** (in.) Rod and Bar (Angled)  
Pipe Material: **Clay** ☐ Pipe Lined  
Invert Depth: **4.88** (ft.) Flow Characteristics: **None**  
Deposits: ☒ None ☐ Mud ☐ Sludge ☐ Debris ☐ Grease  
Silt Depth: **0** (in.) Deposits Extent:  
Infiltration: **None** Pipe Seal Cond: **Sound**
